Sanctuary is Site for Seagrass Restoration Techniques

Alicia Farrer, Environmental Specialist

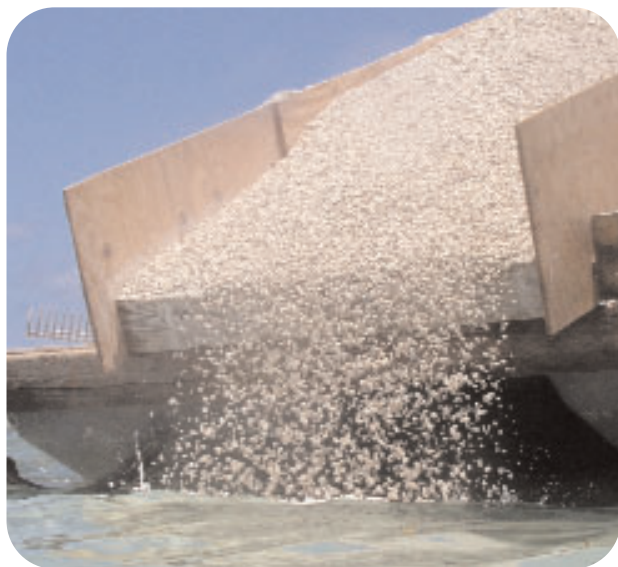
Pearock is poured from a barge to fill a blowhole. Deeper scars and blowholes must be filled because seagrass plants will not grow downward, away from the sun. (Photo: Alicia Farrer)

The scarred seafloor can be returned to its original depth in the deeper blowholes and prop scars by filling the depression with pearock before transplanting. This helps stabilize the substrate to prevent further deterioration from erosion and to prepare the area for colonization by neighboring or transplanted seagrasses. The sediment fill, small limestone pearock from local quarries, is transported by barge to the site and placed into the blowhole or deep scar. Eventually, fine sediments settle out from the water column and fill the interstitial spaces of the pea rock, creating the desired habitat for new seagrass growth.
